# **Intel® Mobile Celeron™ Processor Specification Update**

Release Date: August 1999

Order Number: 244444-007

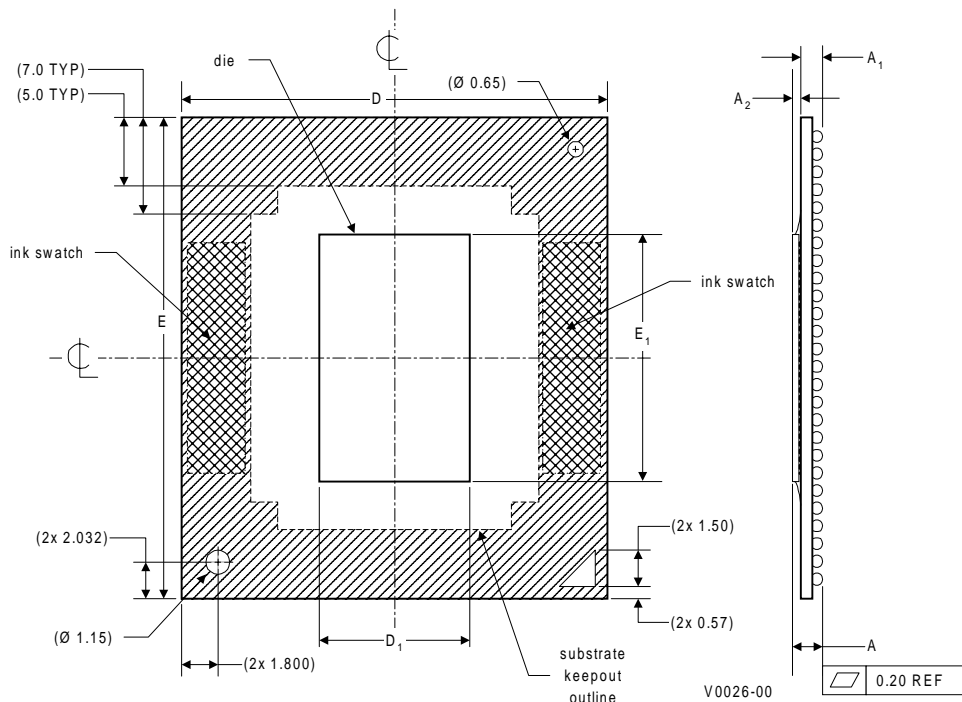
**Figure 5.3. Surface-Mount BGA1 Package—Top and Side View**

The following table and figures show the updated mechanical specifications for the BGA1 package, listed as Table 5.2, Figure 5.3 and 5.4, respectively, in the *Intel® Mobile Celeron™ Processor in BGA Package at 333 MHz, 300 MHz and 266 MHz* datasheet.
